Re: Asbestos Contamination Assessment

On March 11, 2014 Churchill Environmental performed a Contamination Assessment at 68 Main St. Canajoharie, NY in Buildings 38, 45, and 57 due to the disturbance of Asbestos Aircell Pipe Insulation caused by the sub contractor M&M Consulting & Contracting out of Jersey City, New Jersey. The sub contractor was cutting out copper pipes, wiring, and steel. The assessment was performed by Ray Churchill, a certified USEPA/NYSDOL Building Inspector/Project Monitor and Project Designer.

Beechnut Incidental Disturbance Areas

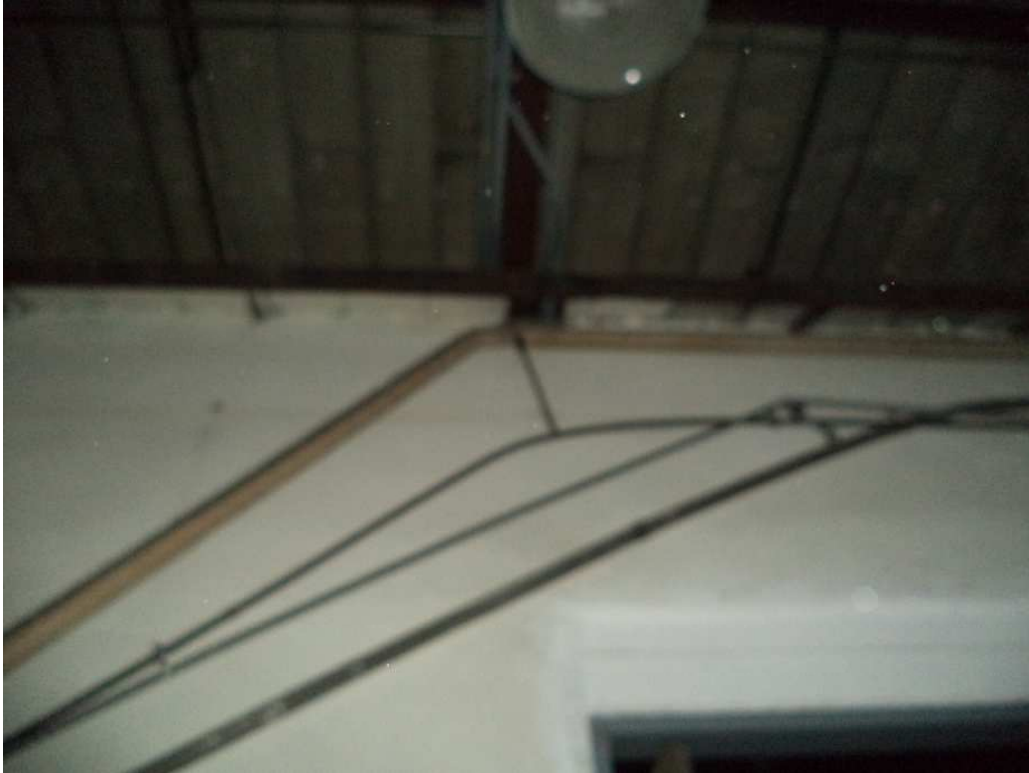
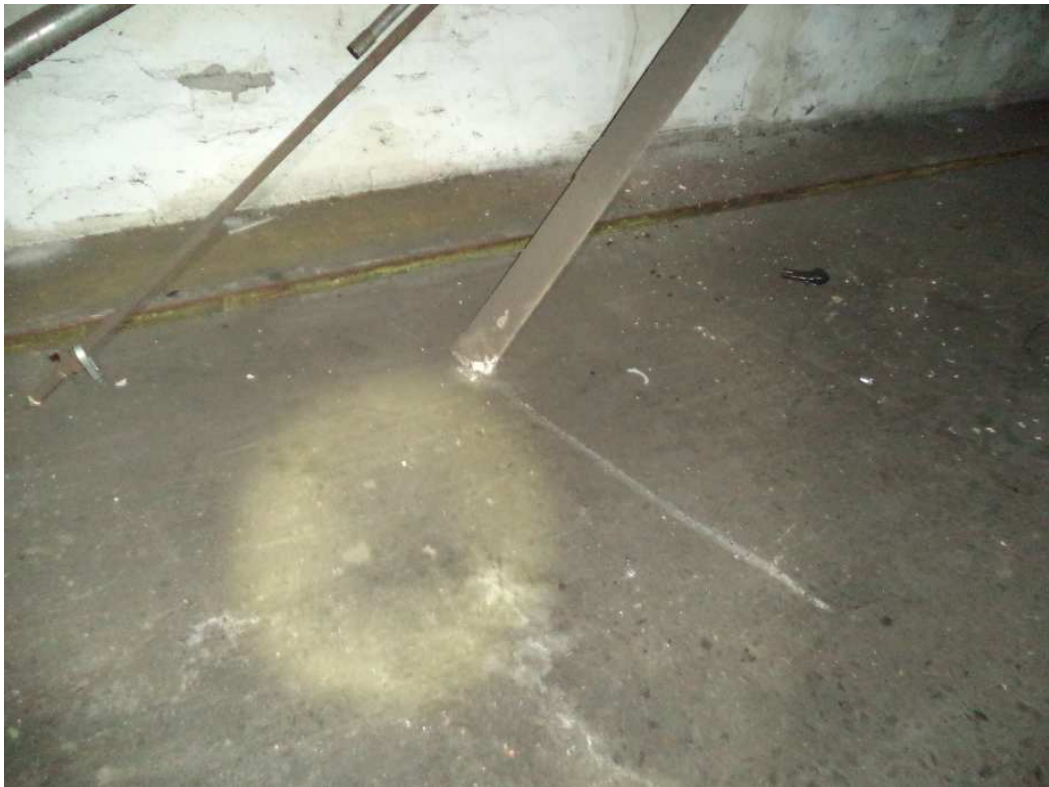
In Building 54, the Pedestrian Walkway a pipe with ACM Aircell under the roof rafters was cut with one end falling to the floor, the other end stayed suspended. The visual inspection found approximately 4' of debris where the pipe dragged after hitting the floor. Four TEM Micro-Vac Samples were taken approximately 15' out from the pipe to see if any asbestos fibers had migrated outward from the pipe. Of the four samples, one had two ACM Chrysotile Fibers in it. The Micro-Vac's were taken using a 100cm squared template and a low-vol pump running at 2 L/M for two minutes. Based on this finding the Contaminated area was moved back another 15' feet from that sample. That entire section of the hallway is considered contaminated. This is Incidental Disturbance #1. See the attached lab results, floor plans, and photos.

The Cut ACM Pipe in the Walkway

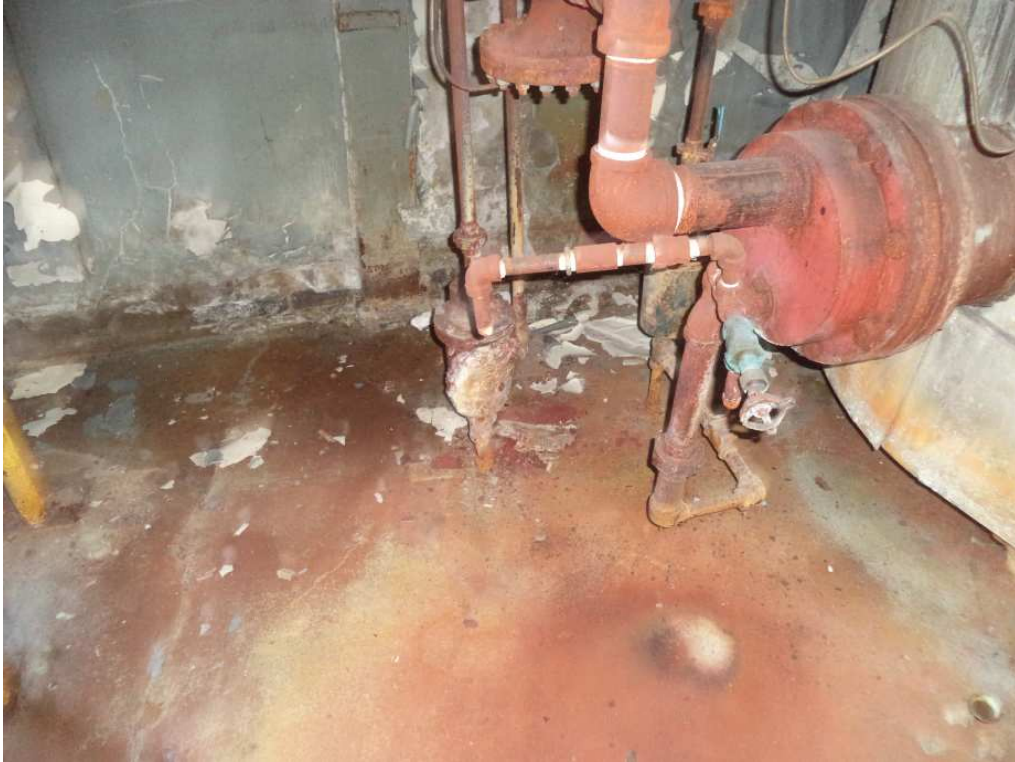
The Tank Disturbance is due to the Matrix of the Pipe Insulation breaking down. There is only 12"-18" of pipe that was on this pipe where it goes into the concrete floor. This is a Minor Disturbance and should have the floor and wall cleaned 2' out from the wall and 4' down from the pipe in each direction along the wall. This is Incidental Disturbance #2

Incidental #2 by the Tank in the NW Corner of Building 38

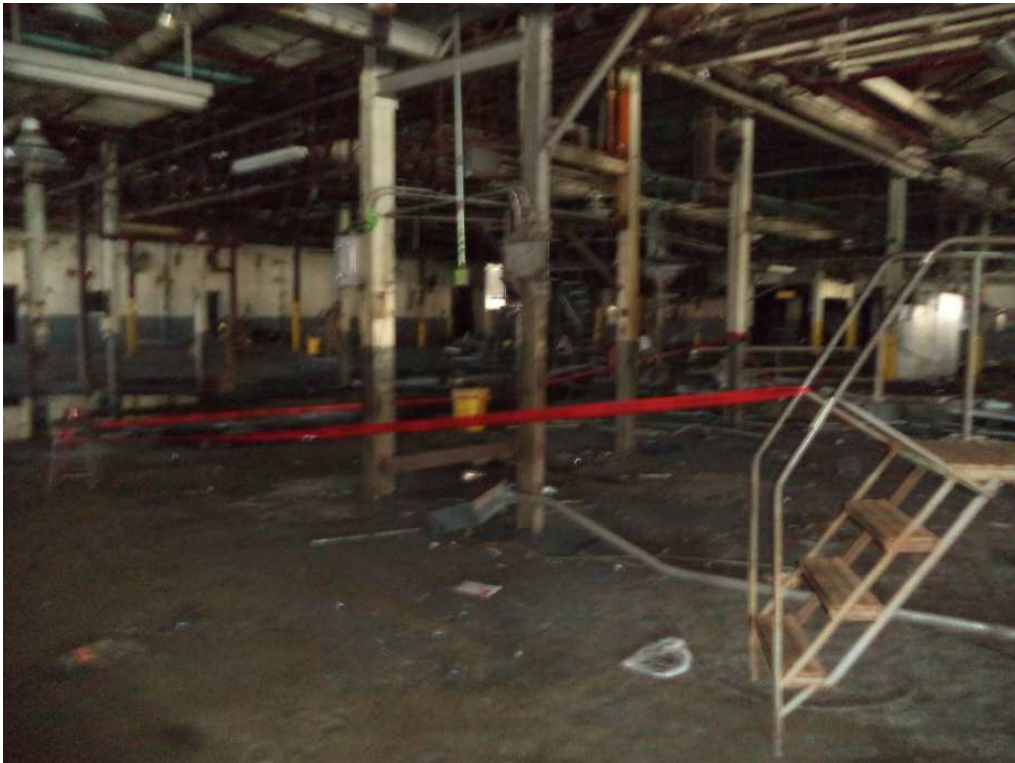
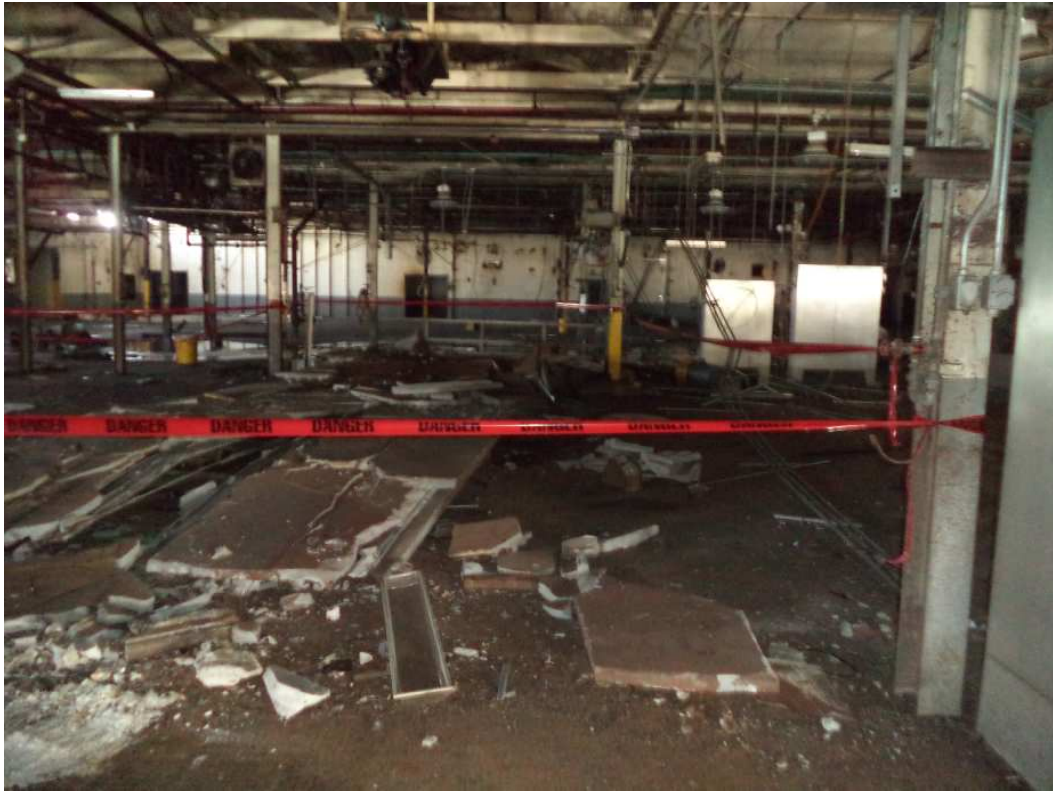
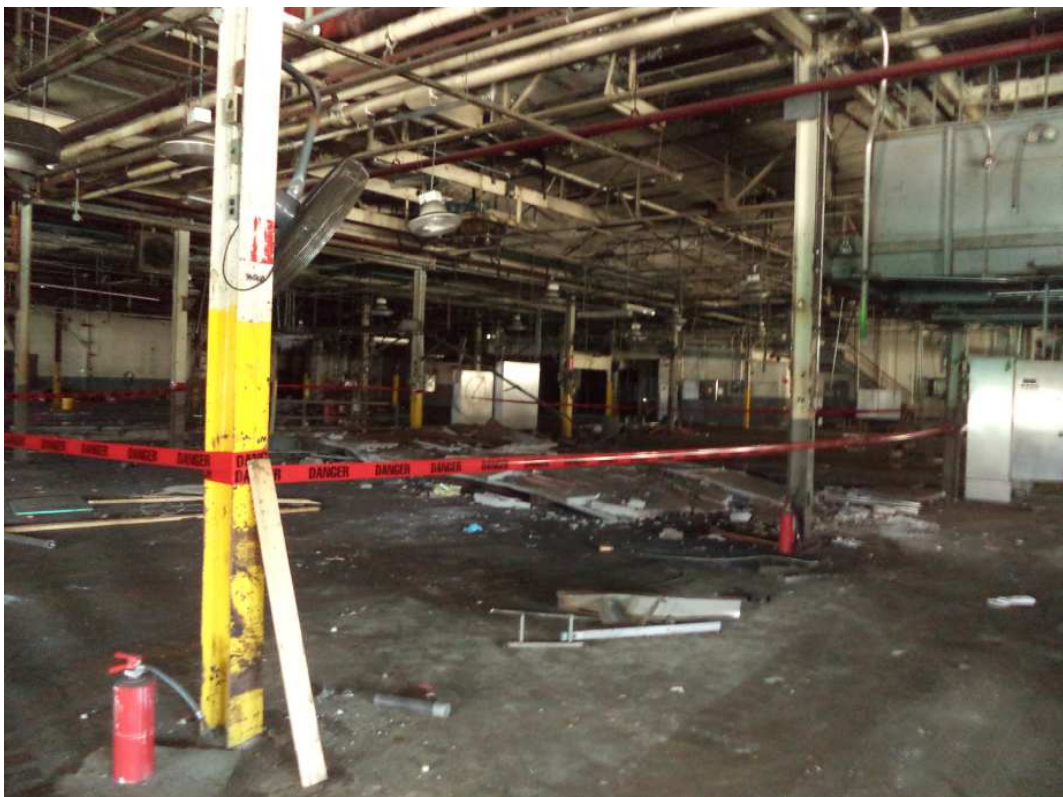
The Disturbance where the Concrete Deck was cut down covers approximately a 30'x 70' area. ACM Debris from the pipes above in the ceiling was found and one Micro-Vac Sample had 1 Chrysotile Fiber in it. The other Micro-Vac's did not have any asbestos in them. The Contaminated Area was determined based on the Visual Inspection, Bulk Samples, and Micro-Vac Samples taken. Where the last seen suspected ACM was seen the area was taken out an additional 1' in each direction. This is Incidental Disturbance #3, #4, and #5.

The Incidental Disturbances of #3, #4, and #5 Combined as one work area.

"Red Danger Tape" and "Asbestos Warning Signs" were used to mark of these areas and prevent anyone from entering them.

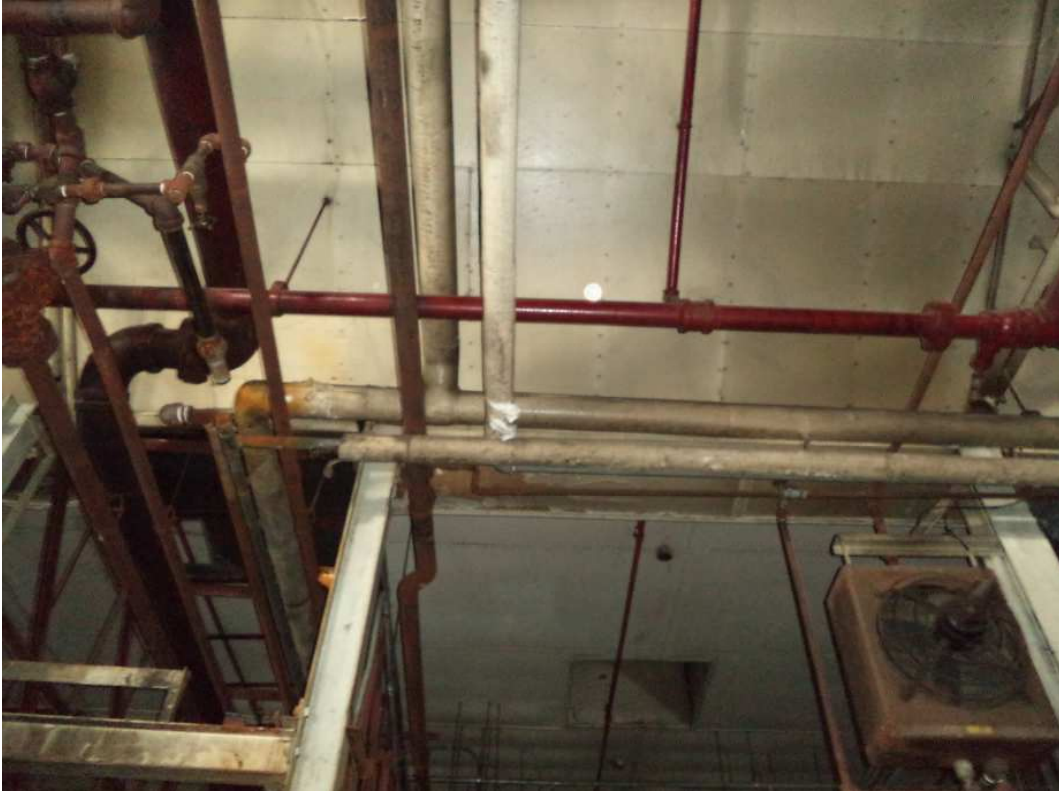
The Damaged Aircell from the removal of the Upper Concrete Deck

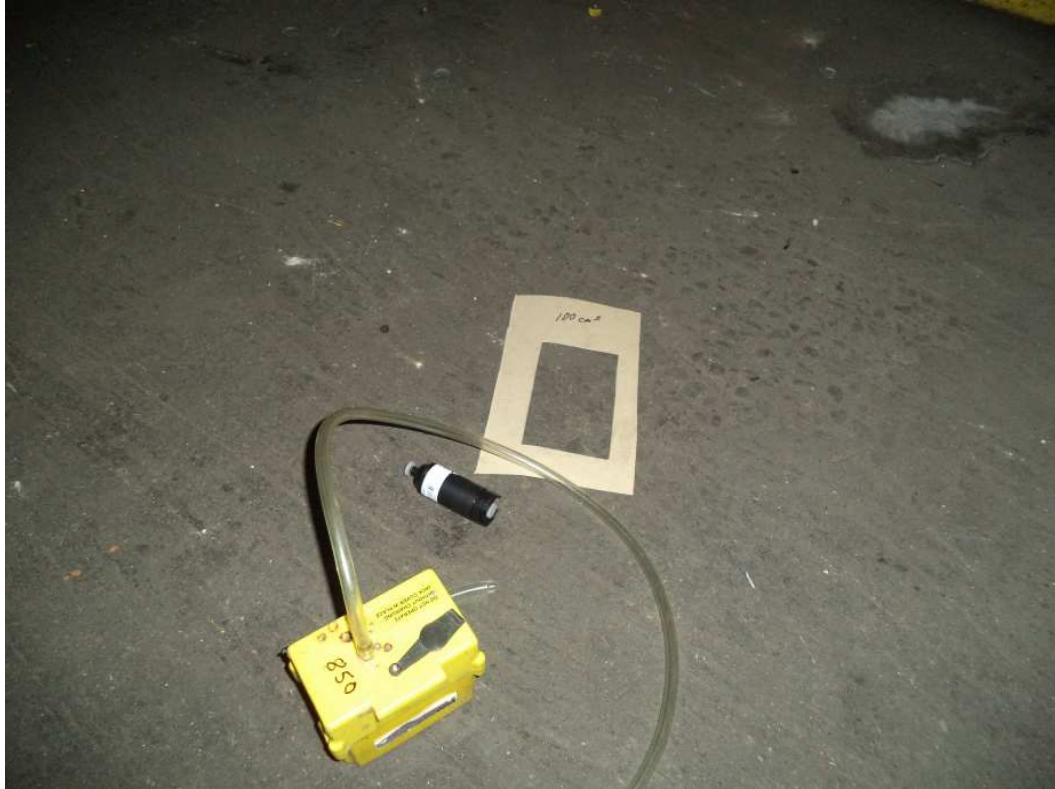
The pump and template used for the Micro-Vac Sampling

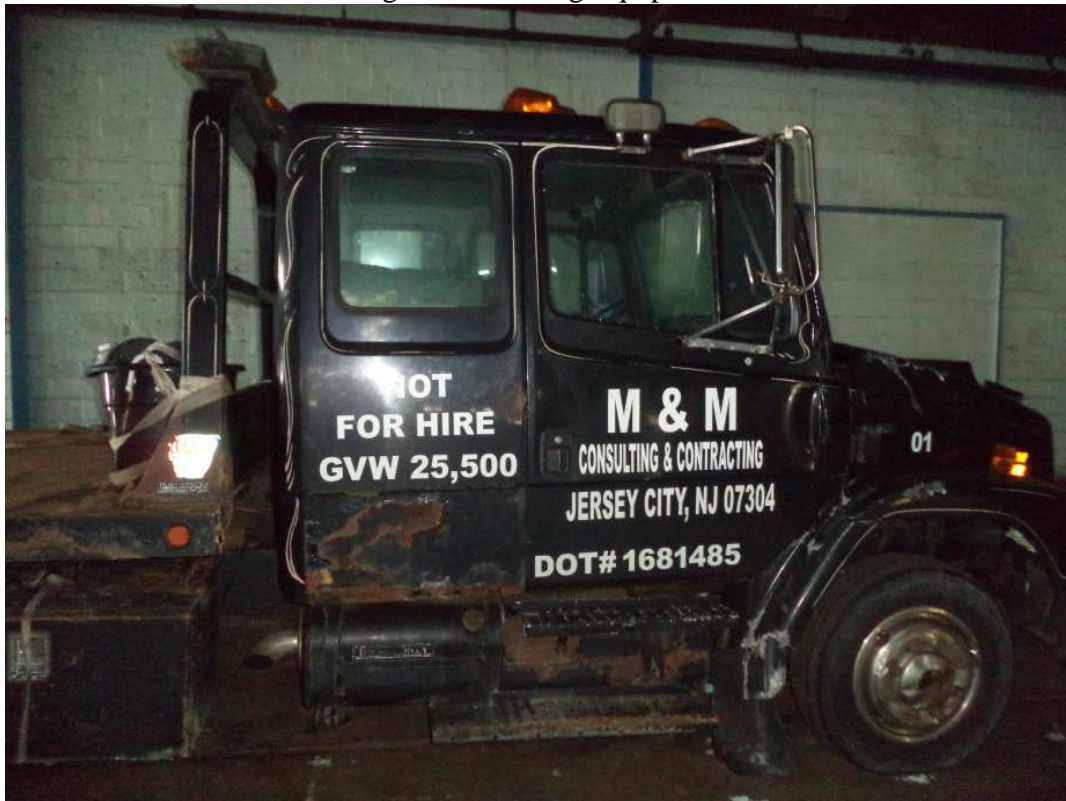
M&M Consulting & Contracting Equipment is still onsite.
